SERVICE LIFE OF HIGHLY FLEXIBLE COUPLINGS

THEORETICAL EXPECTED LIFETIME

SERVICE LIFE - RATO S / S+

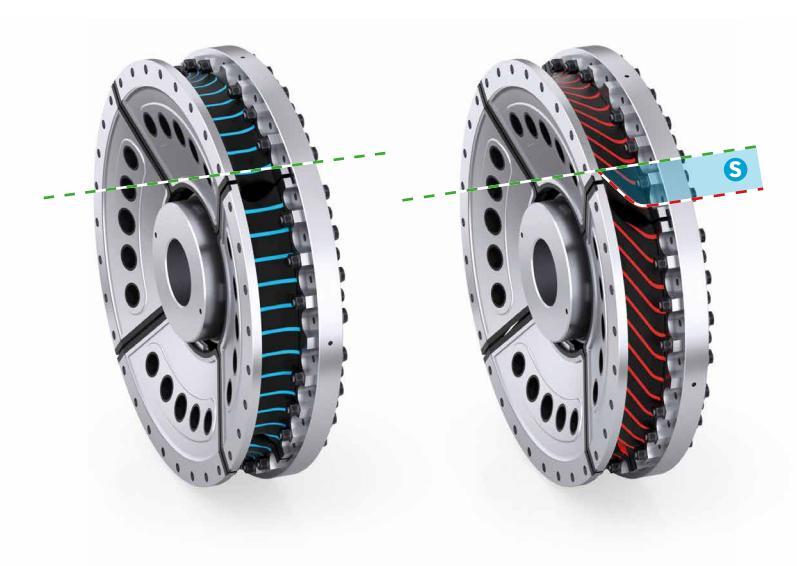
Figure 1

Checking the permissible permanent set of a RATO S / RATO S + segment takes place by obtaining **S** at the outer diameter of the rubber element. Therefore, see (Figure 1 and Figure 2). In case the maximum value is reached, the flexible element has to be replaced.

PERMISSIBLE PERMANENT SET RATO S

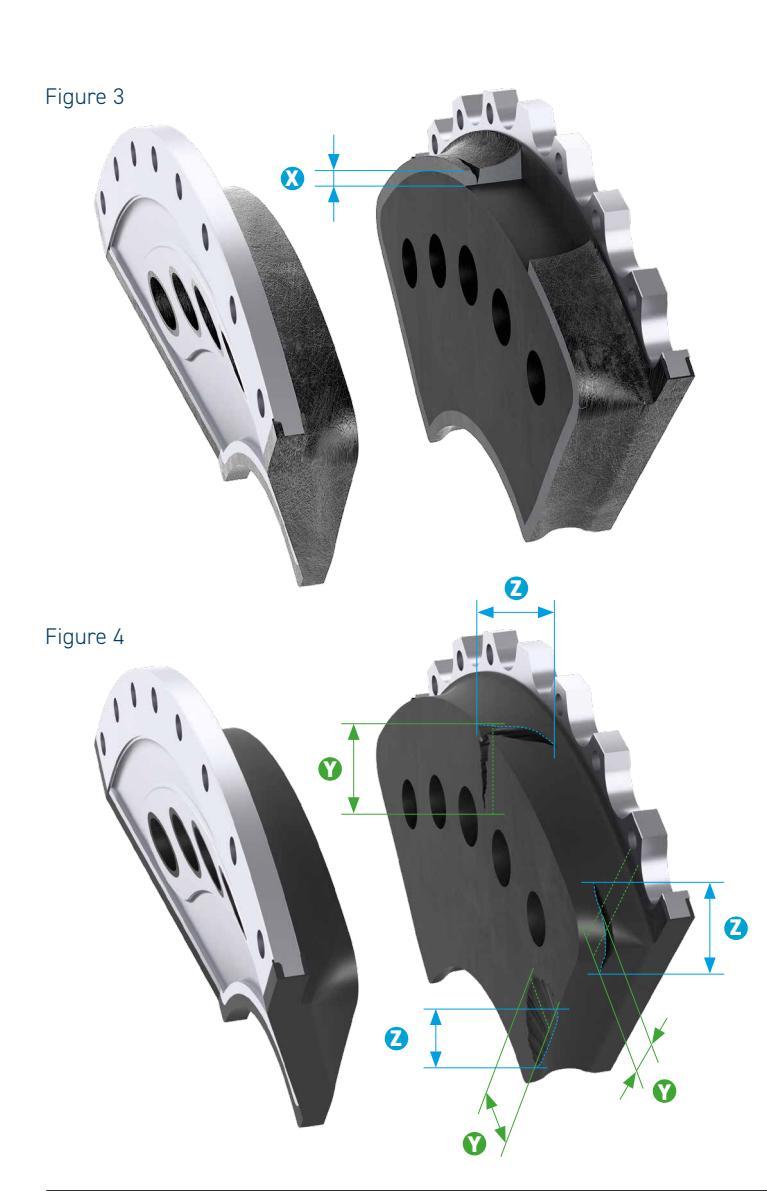
As a result of the deformation, aging and load of the flexible element during normal operation, cracks may get formed that are permissible in our natural rubber elements up to a certain limit (Figure 3 and Figure 4). Depending on size, visual shape, age and location of cracks a rework by grinding and coating could be recommended in order to extend the total lifetime. Surface cracks in the flexible element of a RATO S / RATO S+ coupling are permissible, if these cracks occur on all sides of the entire rubber surface up to a depth as mentioned (Figure 3, depth O). With defined cracks predominantly in the outer rubber surface, the segment faces and segment corners the maximum allowed length and depth is mentioned in the table (Figure 4, depth O, O). If the permissible influenced area as a combination of the mentioned cracks is exceeded, it is recommended to replace the flexible element as soon as possible.

PERMISSIBLE DEPTHS OF CRACKS RATO S
